NATIONAL TRANSPORTATION SAFETY BOARD

SAFETY RECOMMENDATIONS

ADOPTED SEPTEMBER 2002

In reply refer to: H-02-15 through -18

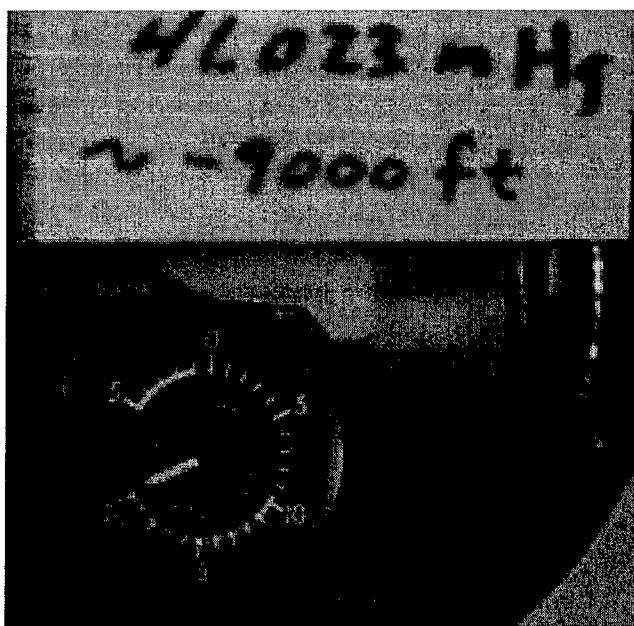
Figure 1. Cabin altimeter from an Airbus A300 airplane.

The cabin altimeter is located on the cockpit overhead panel and is marked with values from 20,000 to -5,000 feet. (Figure 1 shows a cabin altimeter from an Airbus A300 airplane.) Unmarked space separates the -5,000-foot mark and the 20,000-foot mark on the gauge. The needle on the gauge moves clockwise into the positive range to indicate higher cabin altitudes as the cabin pressure decreases and moves counterclockwise to indicate lower cabin altitudes as the cabin pressure increases. The investigation determined that when cabin pressure increases such that the cabin altitude is less than -5,000 feet, the cabin altimeter needle moves counterclockwise through the negative altitude range, including past the -5,000 mark, through the unmarked area, and into the highest end of the positive altitude range. There are no mechanical stops on the cabin altimeter that restrict the needle to the marked areas of the gauge and prevent the needle from traveling to the positive altitude range when the cabin altitude is actually beyond -5,000 in the negative range.

The investigation determined that at one point during American Airlines flight 1291's approach to MIA, the cabin altitude reached -12,100 feet. Specifically, at 1212:31, the CVR recorded a sound similar to a lavatory smoke detector. During postaccident testing of the

The Safety Board notes that if the cabin altitude were displayed on a digital display or if the existing cabin altimeter gauge design had a broader range of values, the flight crew would likely have gotten an accurate cabin altitude reading. The Board is concerned that the potential to misinterpret an overpressure condition as a low pressure condition exists on all aircraft that do not have cabin altimeters that accurately display cabin altitude, particularly when the pressurization system is being operated in the manual mode. Therefore, the Safety Board believes that the FAA should conduct a survey of transport-category aircraft to determine which are equipped with cabin altimeters that are capable of displaying indications beyond the marked ranges of the gauge and require that the cabin altimeter gauges on those airplanes be modified to ensure that they will indicate the correct cabin altitude to the flight crew, particularly when the pressurization system is being operated in the manual mode. This could be accomplished either by the replacement of the gauge with a digital display, by the expansion of the values on the existing gauge design, or by other means.
